# **Missouri River – Fort Peck Dam to Ponca State Park Geomorphological Assessment Related to Bank Stabilization**

U.S. Army Engineer Research and Development Center

*December 2001*

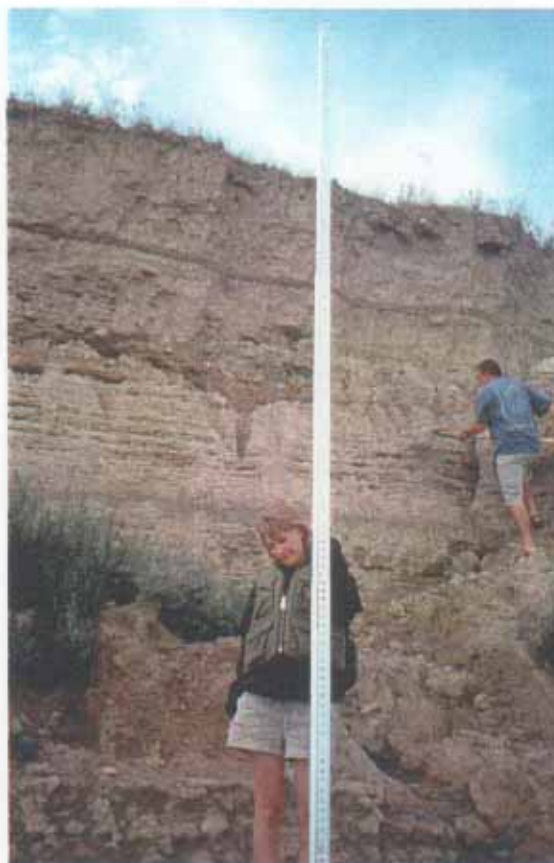
**Figure 4.1** Fort Peck Reach – sampling eroding right bank at WPT 149, RM 1626.8.

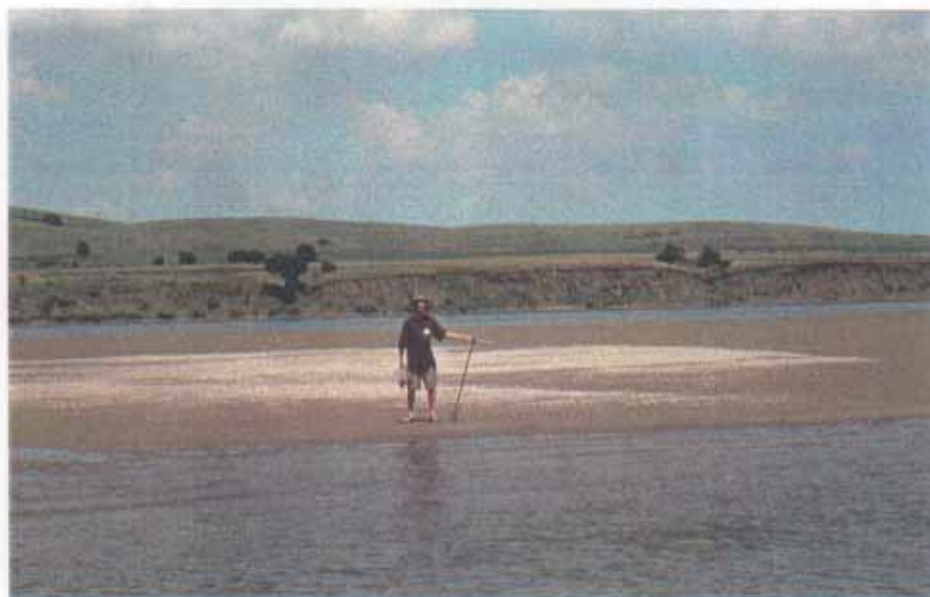
**Figure 4.2** Fort Randall Reach – Plover habitat bar at WPT 069, RM 864.8.

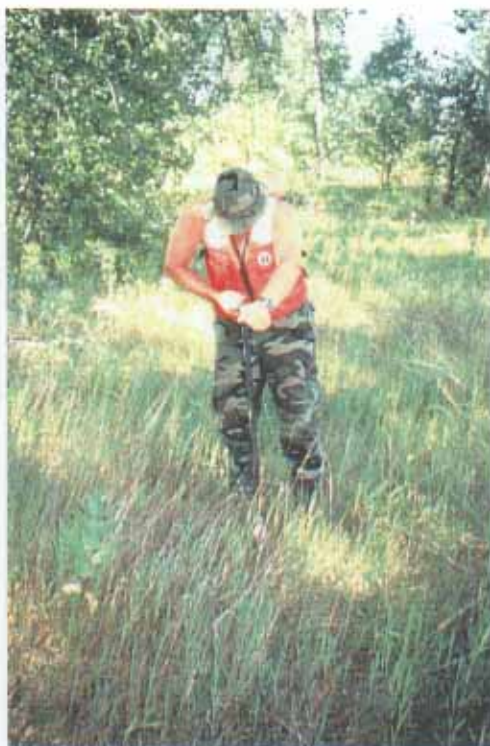
**Figure 4.3 Garrison Reach – sampling vegetated island at WPT 103, RM 1376.6.**

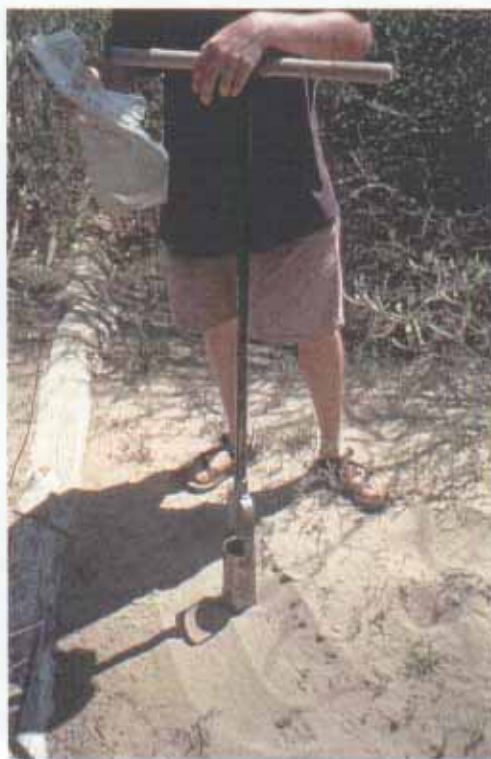
**Figure 4.4 Fort Randall Reach – core sampler on island at WPT 073, RM 875.8.**

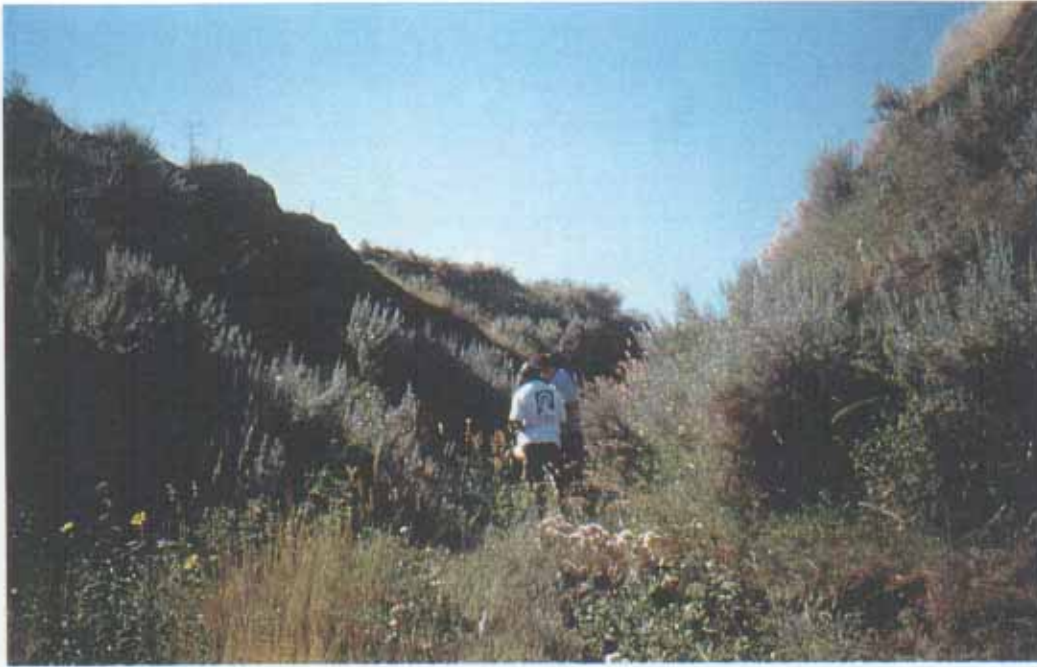
Figure 4.6 Fort Peck Reach – arroyo at WPT 285, RM 1731.5.

The ephemeral tributaries sampled (i.e., arroyos) were only those which flow directly into the Missouri. The sediment samples at these sites were taken with a hand-held auger as outlined in the bar and island section. The samples were taken in the approximate center of the arroyo (Figure 4.6). The only obvious arroyo's were encountered in high bluffs. Other arroyo's had to be distinguished from true runoff access points, and cattle paths leading to the water's edge.
